# **Debris/Ice/TPS Assessment and Integrated Photographic Analysis of Shuttle Mission STS-81**

*Process Engineering/Mechanical System Division/ET-SRB Branch,  
Kennedy Space Center, Florida*

**12 January 1997**

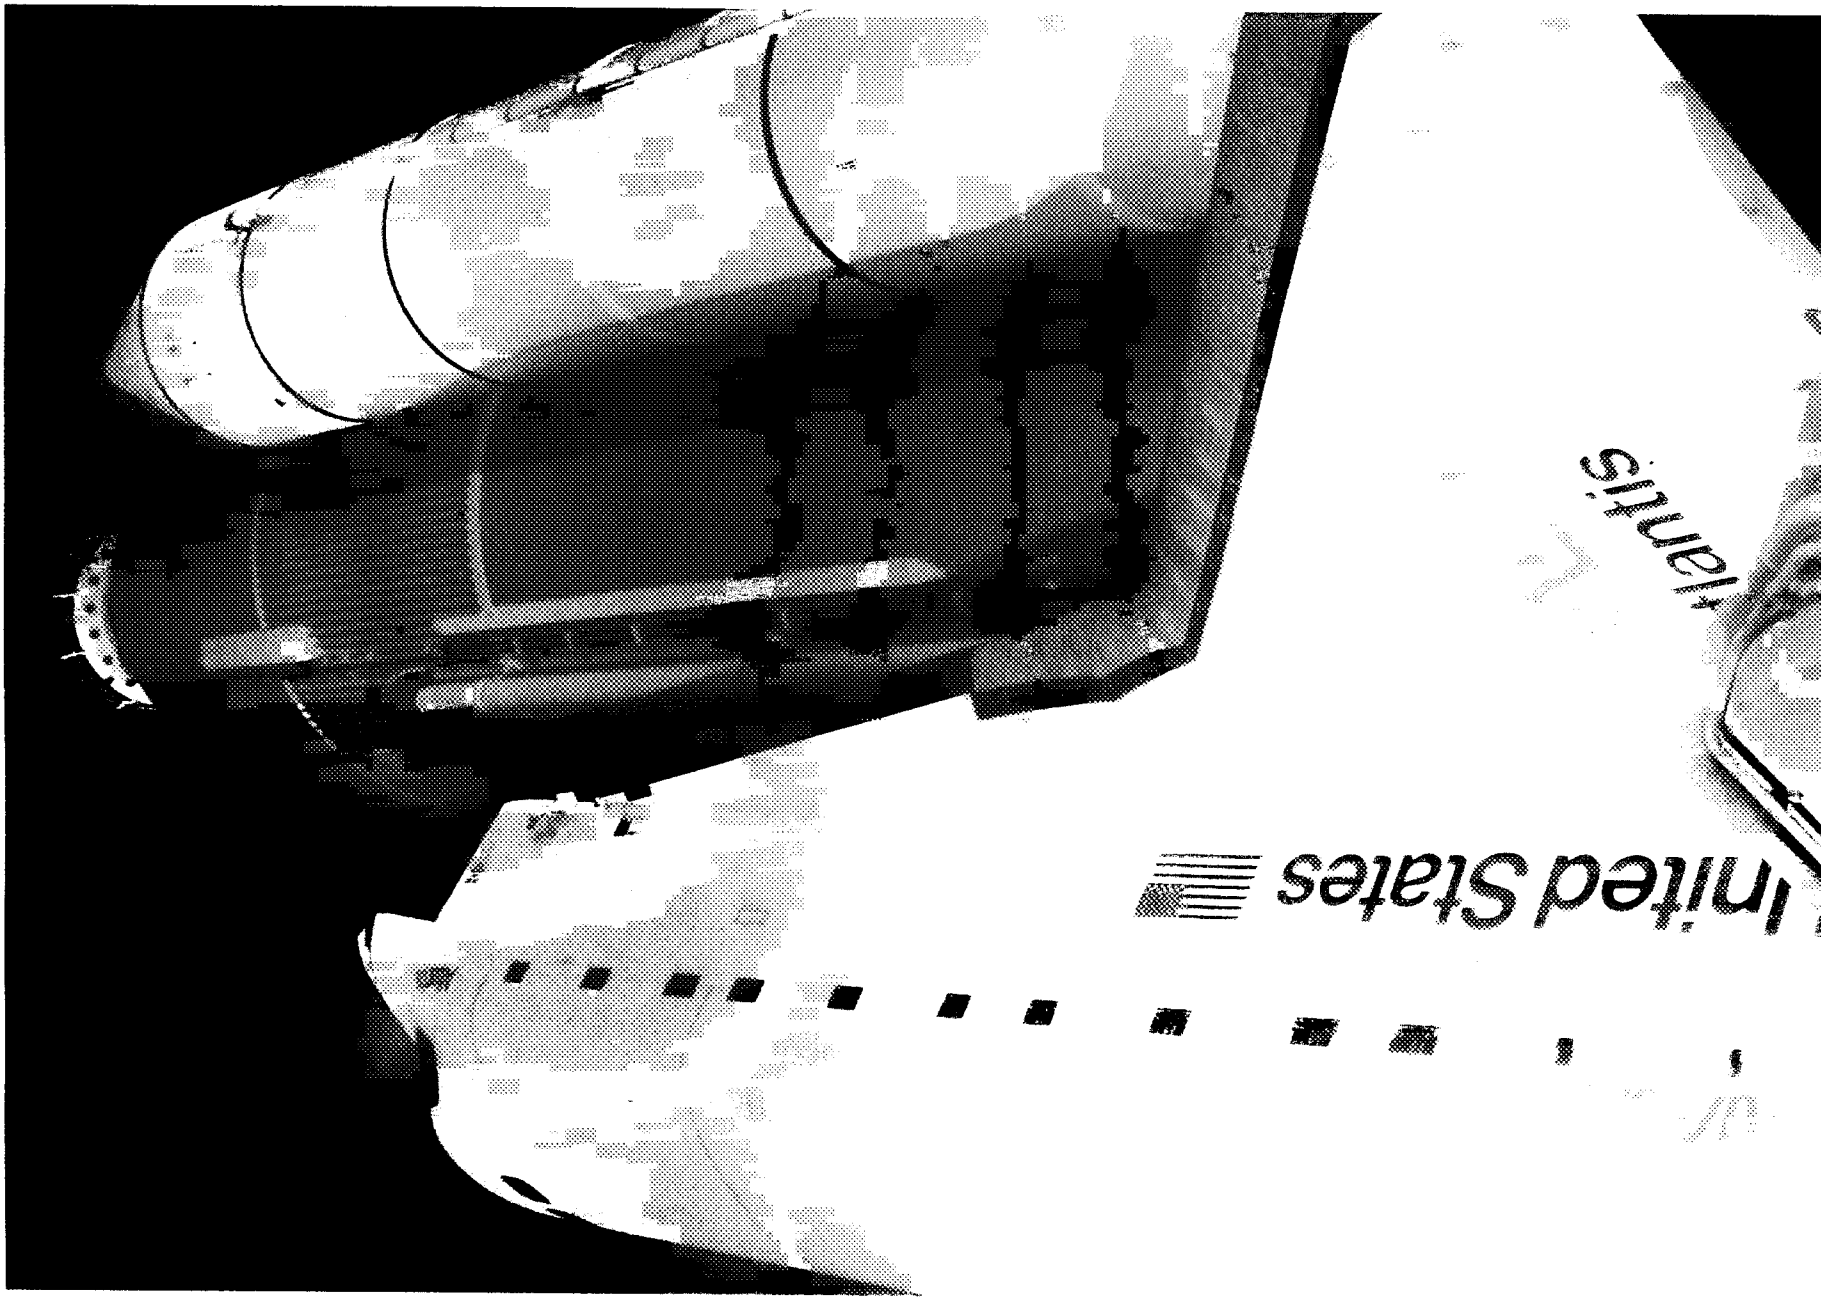
Photo 2: STS-81 Cryoloaded for Flight

The Final Inspection Team observed light condensate and isolated patches of frost, but no ice accumulations, on the LO2 tank. TPS surface temperatures ranged from 31 degrees F (in the frosted areas) to 41 degrees F (on the ogive).

OV-104 Atlantis (18th flight), ET-83 (LWT 76), BI-082 SRB's

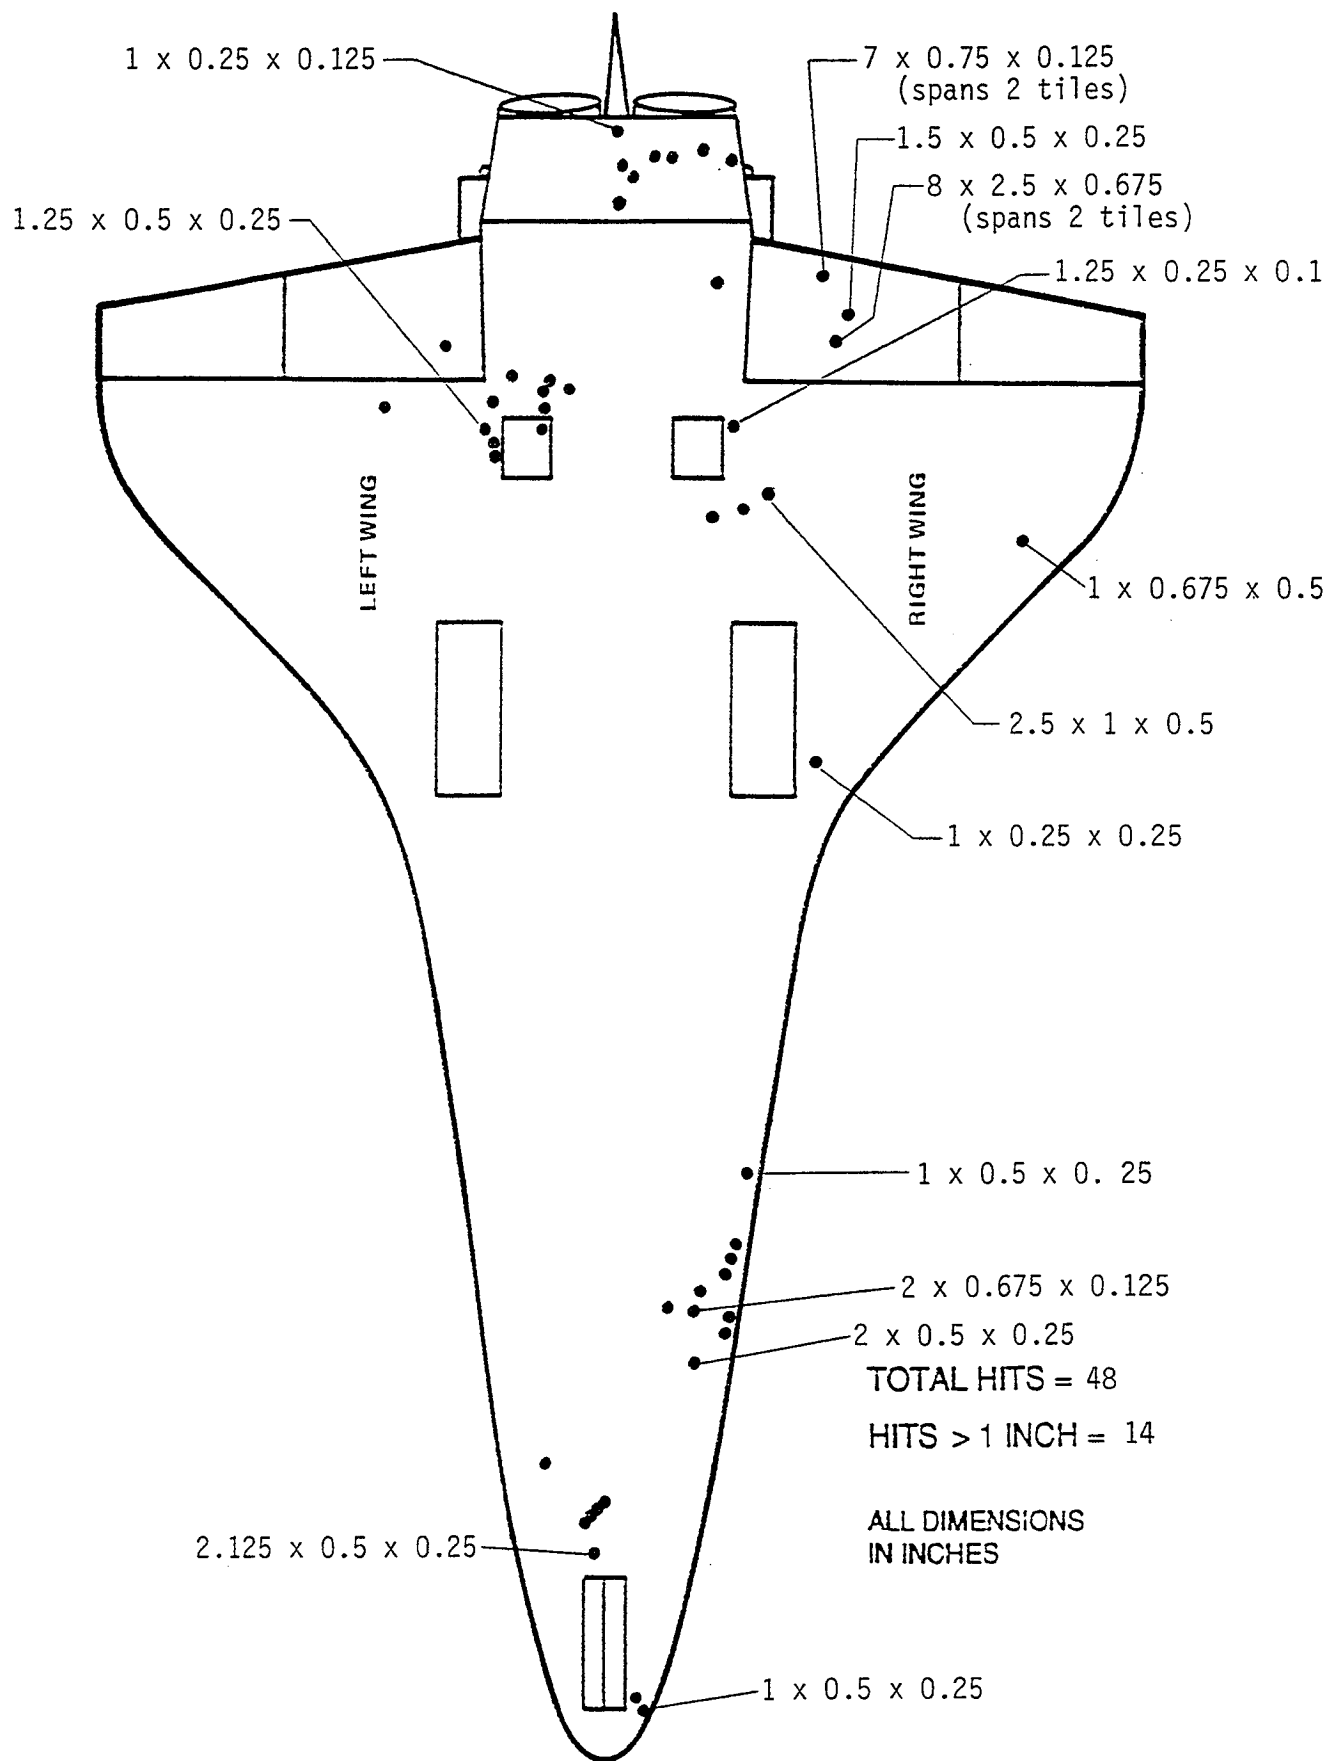
Figure 3: Orbiter Lower Surface Debris Map

The largest lower surface tile damage site was located on the right inboard elevon, spanned two tiles, and measured 8.0-inches long by 2.5-inches wide by 0.675-inch maximum depth. The depth of the damage site indicates a probable impact by ice - possibly from the ET LO2 feedline bellows.

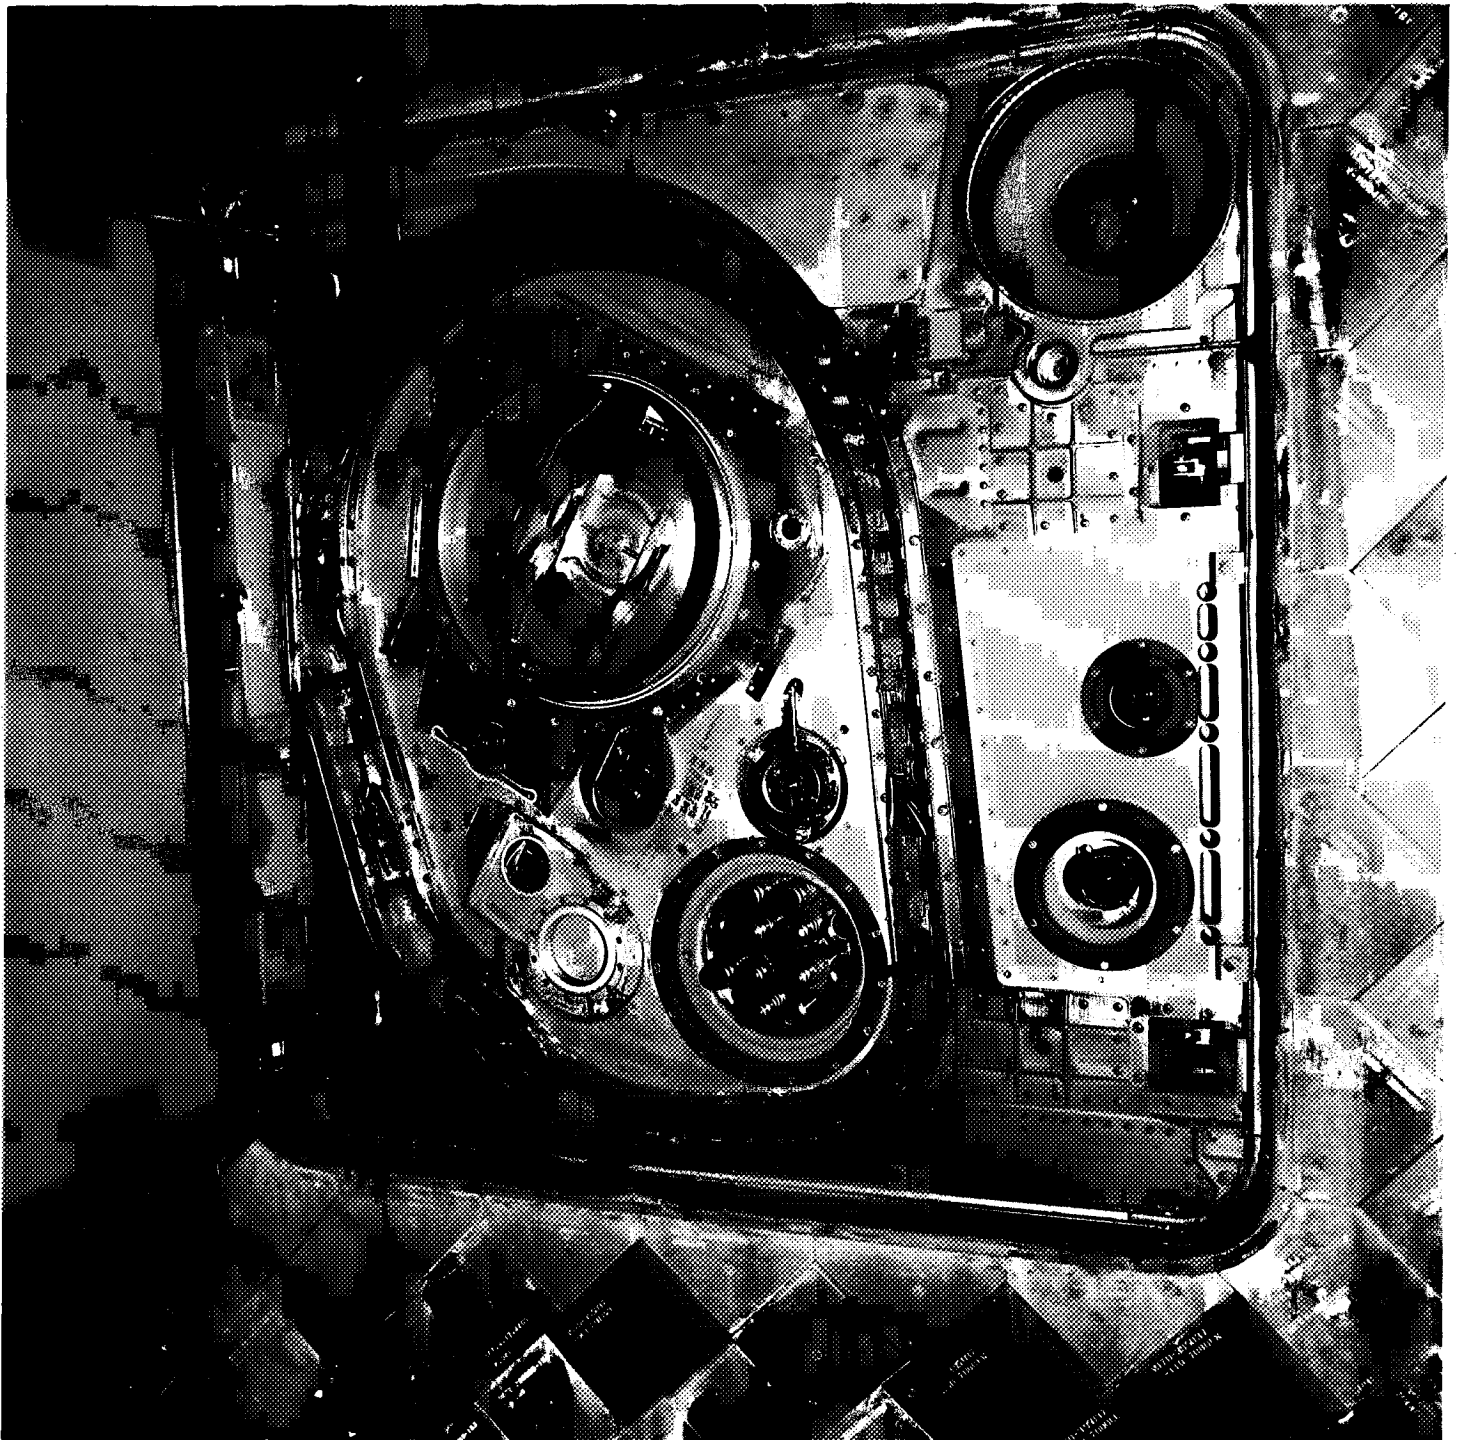
Photo 25: LH2 Umbilical

Two spring clips were missing from the EO-3 "salad bowl"

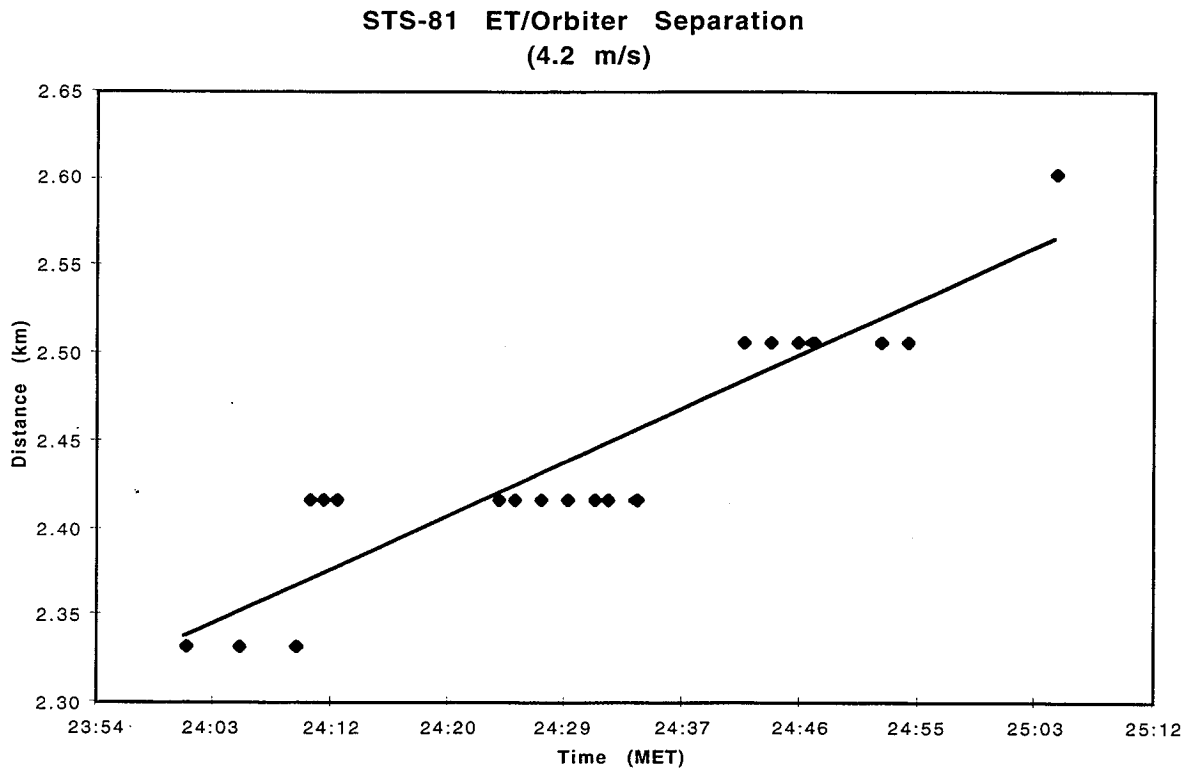
Figure 2.4.2 (B) ET Separation Velocity

The distance of the external tank was calculated over a twenty-frame sequence using the handheld photography. The external tank was calculated to be a distance of 2.3 km away from the Orbiter at 24:01 MET. The tank was calculated one minute four seconds later (25:05 MET) to be at a distance of 2.6 km. The tank separation velocity was determined to be 4.2 m/s with an uncertainty of approximately 0.1 m/s. See figure 2.4.2 (B). (Note that the distance of the ET appears to remain constant over multiple frames due to the resolution limitations of the imagery). The separation velocity was similar to previous mission measurements. The tank tumble rate was estimated to be 0.3 deg/sec and the roll rate was too small to be measured.

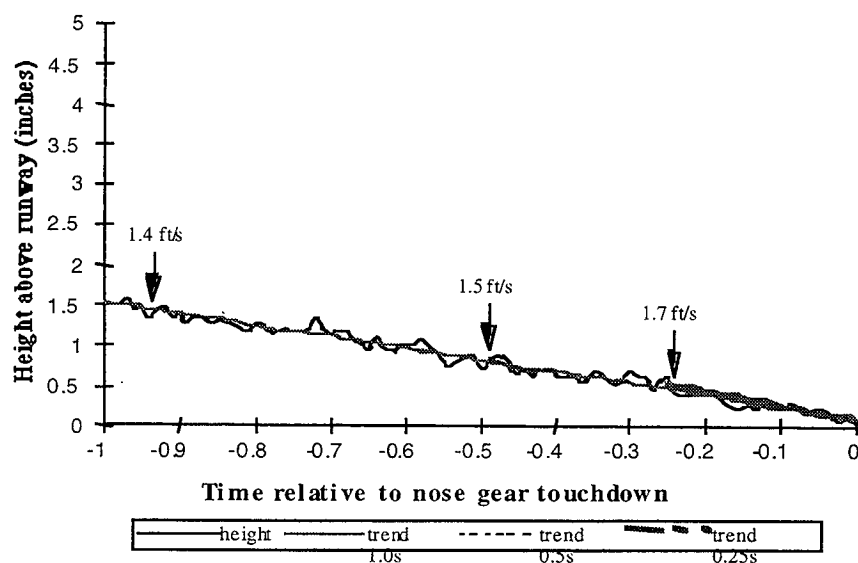
Figure 2.5.1 (A) Main Gear Height Versus Time Prior To Touchdown (Video)

The measured main gear sink rate values were found to be below the maximum allowable values of 9.6 ft/sec for a 211,000 lb. vehicle and 6.0 ft/sec for a 240,000 lb. vehicle (the landing weight of the STS-81 Orbiter was reported to be 214,916 lb.). The sink rate measurements for STS-81 are given in Table 2.5.1. In Figure 2.5.1 (A), and 2.5.1(B), the trend of the measured data points for the image data is illustrated.
